UH-1N SALT WATER SPRAY INGESTION TESTS (CATEGORY II FOLLOW-ON TEST PROGRAM)

TECHNICAL REPORT No. 72-39

OCTOBER 1972

**AIR FORCE FLIGHT TEST CENTER
EDWARDS AIR FORCE BASE, CALIFORNIA
AIR FORCE SYSTEMS COMMAND
UNITED STATES AIR FORCE**

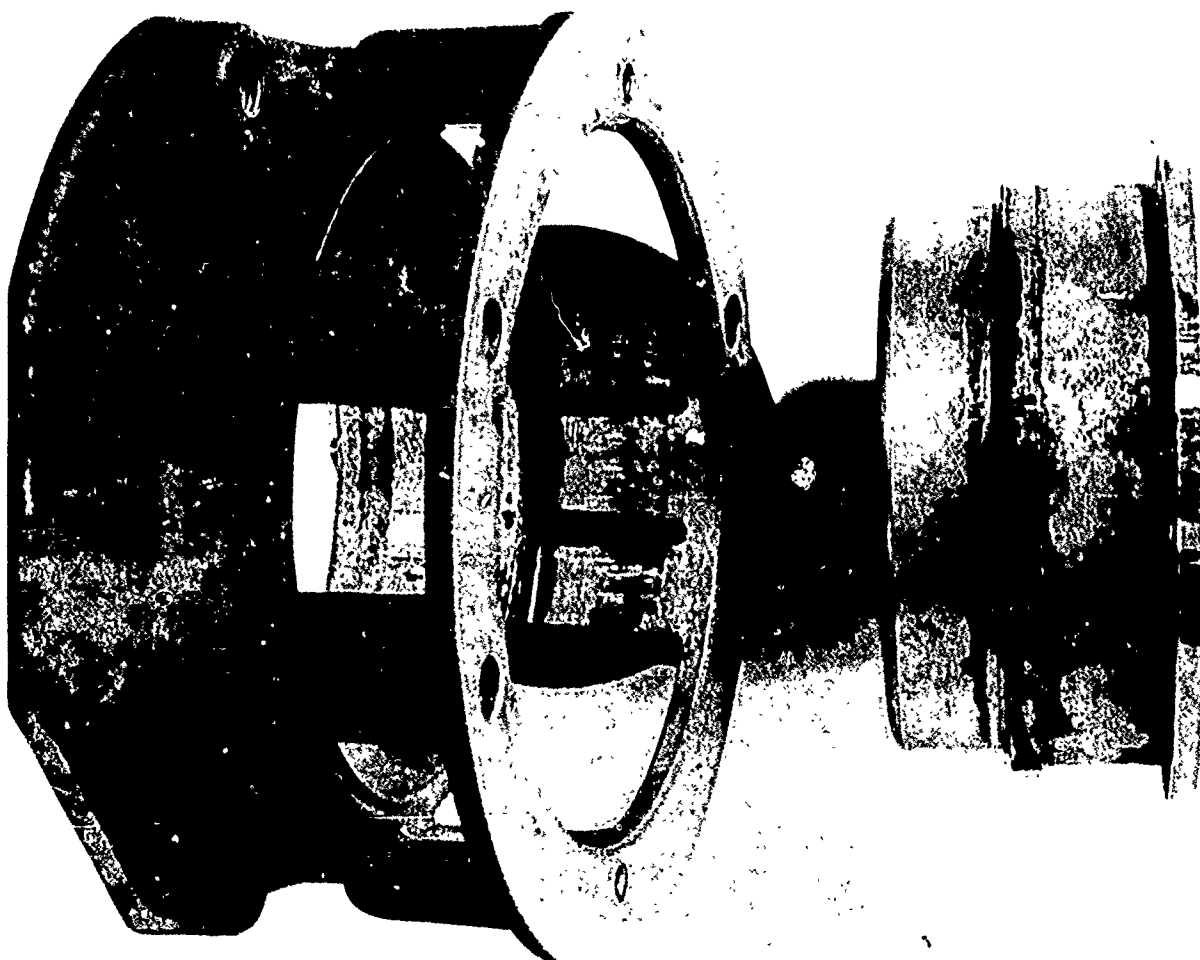
Figure 6 Disassembled Right Engine Compressor Bleed Valve

The removed bleed valve was found to be worn and scored where the valve was sticking in the valve sleeve. No evidence of salt water corrosion or other evidence of detrimental effects of hovering in the salt spray were found on the bleed valve. Figure 6 illustrates the scoring on the disassembled bleed valve.

The malfunctioning bleed valve is felt to have been responsible for the continued decline of the right engine after the test team returned to Edwards. It is not believed to have been totally responsible for the loss of power during flight 19 and subsequent flights through 22. This is evidenced by the behavior of the engine after the bleed valve was changed.

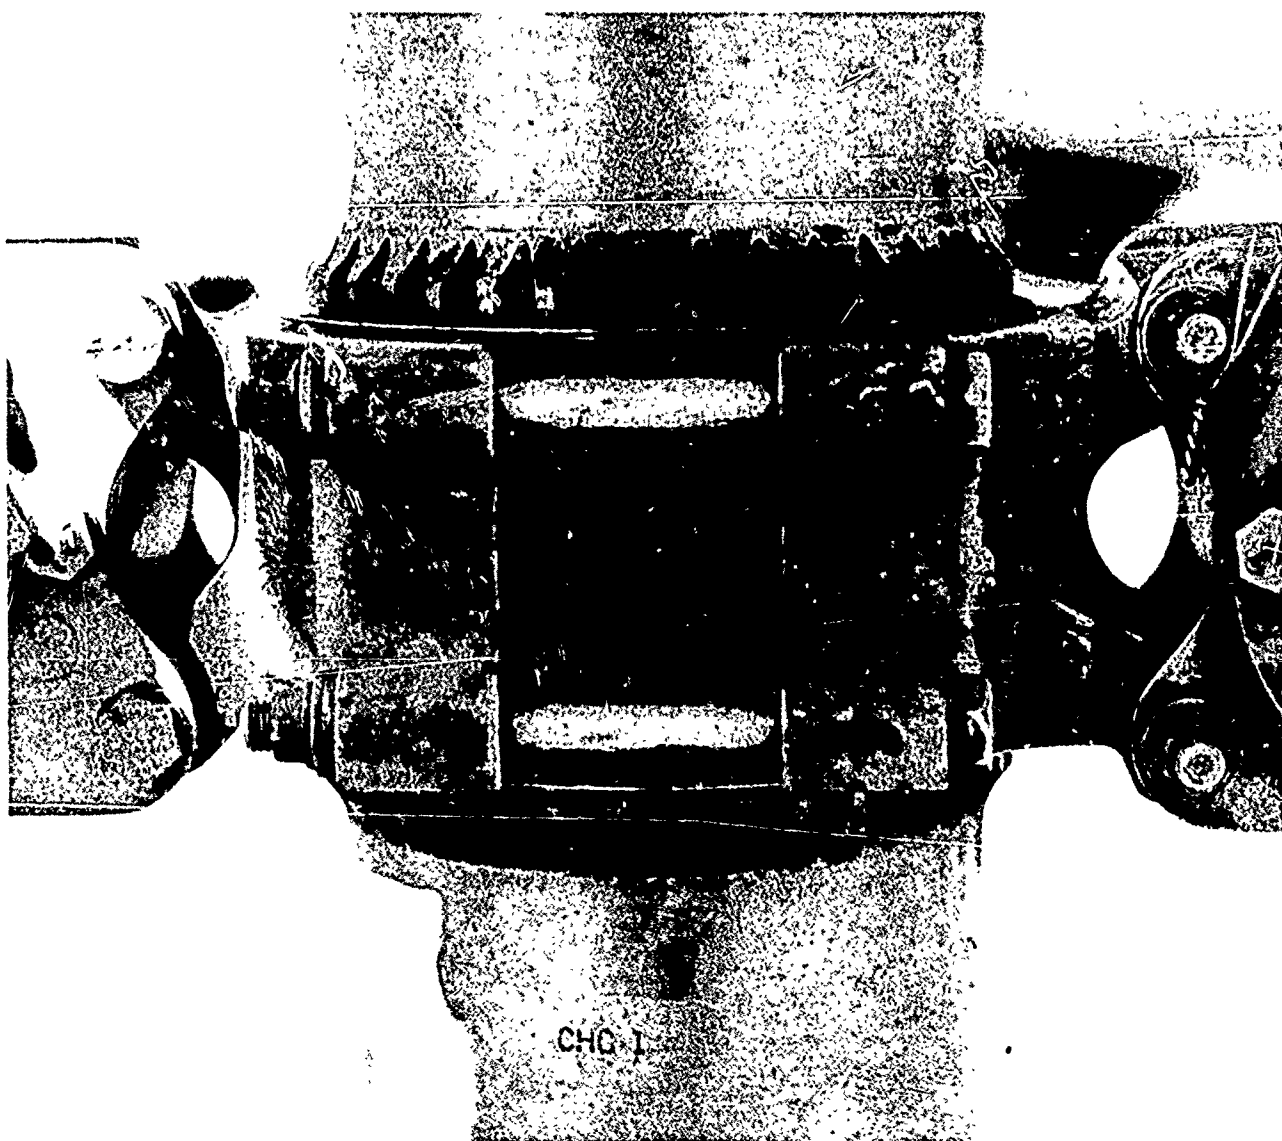
Figure 10 Corrosion of the Mast Spline Shaft at Damper Mounts

Zip Aerosol Corrosion Shield reduced the total corrosion which did occur on the aircraft, but it was not totally effective in preventing corrosion. Appendix III presents a corrosion summary by aircraft section of the corrosion events which occurred at NAS North Island. Figure 10 illustrates the corrosion formed on the mast spline shaft at the damper mounts.

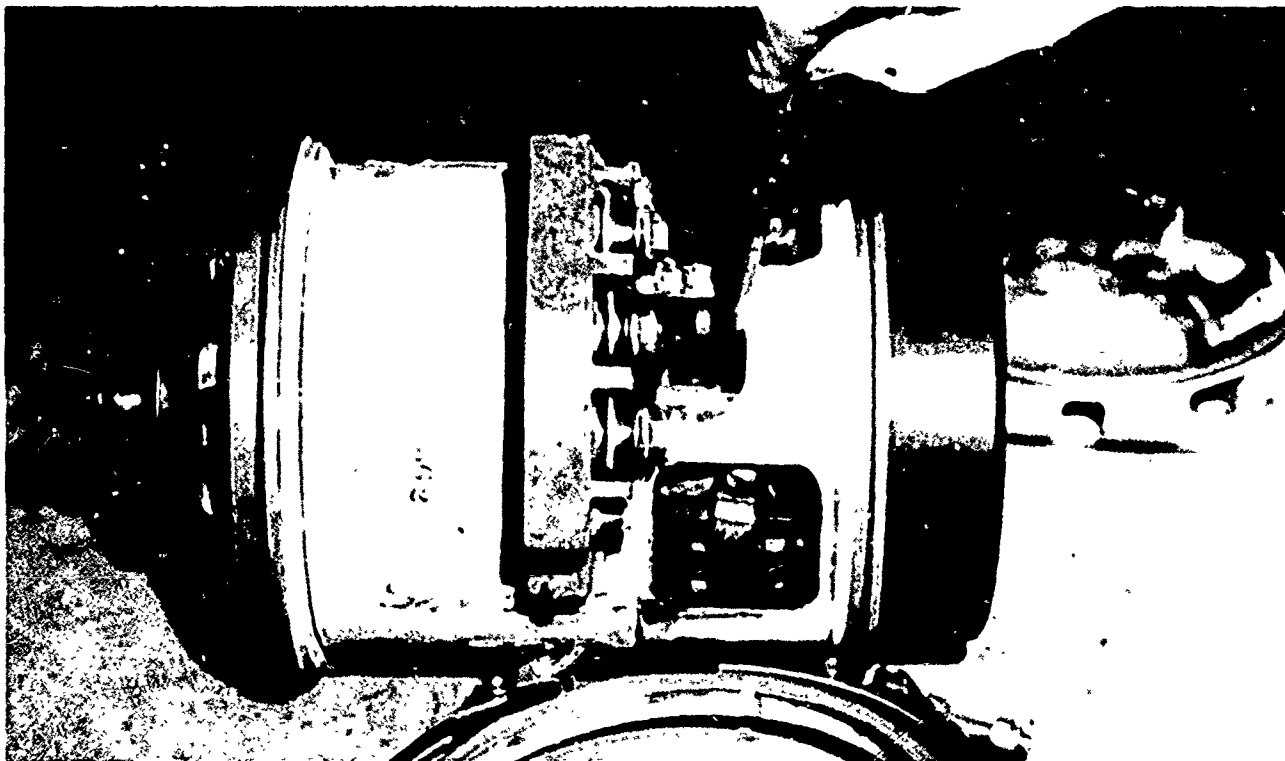
Figure 11 Corrosion of Left Engine Starter-Generator

The exact condition of the generator prior to initiation of the test program is not known. It cannot be positively concluded, therefore, that the corrosion found on the generator was caused by hovering in salt spray. However, the possibility that this was the case is strong enough that it cannot be ignored.

It can be positively concluded that hovering in salt spray will cause extensive aircraft corrosion unless adequate corrosion control is practiced on a daily basis. This corrosion may be obvious or insidious and may prove to be a more serious problem than engine power degradation resulting from sustained hovering in salt spray. Hovering in salt spray should be kept to the minimum time required to accomplish an operational mission and hover altitude should be as high as is practical for that mission. (R 10)
